## **Evaluation of Minimum Asphalt Concrete Thickness Criteria**

Haley P. Bell and L. Webb Mason

October 2008

Final report

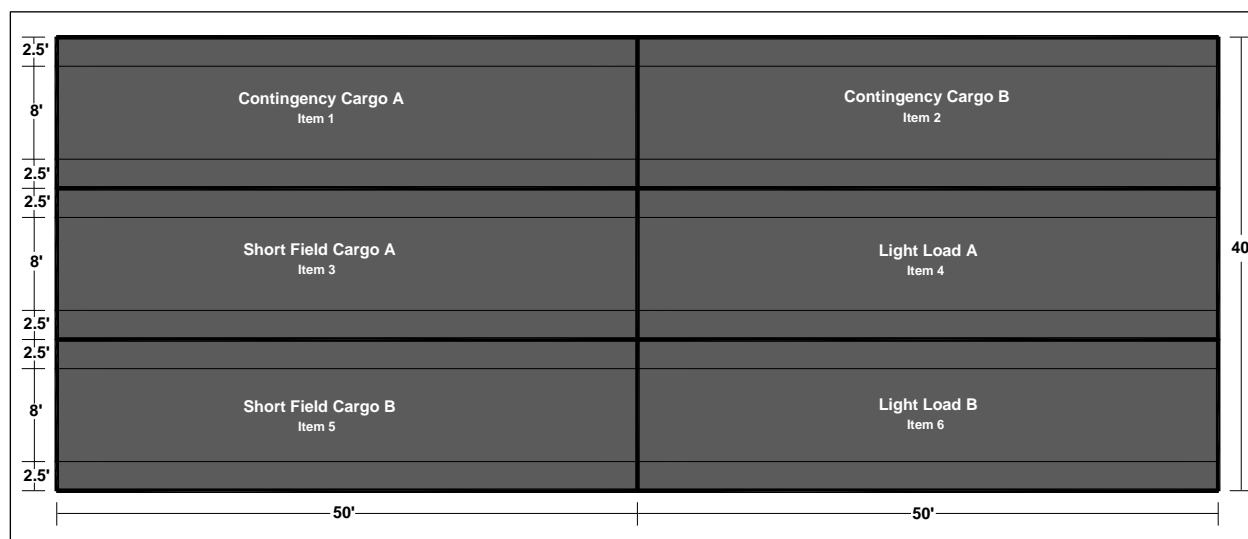
Figure 2. Plan view of test section.

Two items (Items 1 and 2) were constructed under the minimum asphalt concrete thickness requirements (2.5 and 3.5 in. of asphalt concrete, respectively). The base course for Items 1 and 2 consisted of crushed gravel. Items 3, 4, 5, and 6 were constructed within the limits of the minimum asphalt concrete thickness criteria. Items 3 and 4 were constructed of 4 in. of asphalt concrete with a crushed limestone base course. Items 5 and 6 were constructed of 5 in. of asphalt concrete with the crushed gravel base course. All items consisted of a 3:1 blend of crushed gravel and sand for the subbase and high-plasticity clay for the subgrade. Figure 2 shows a plan view of the test section.

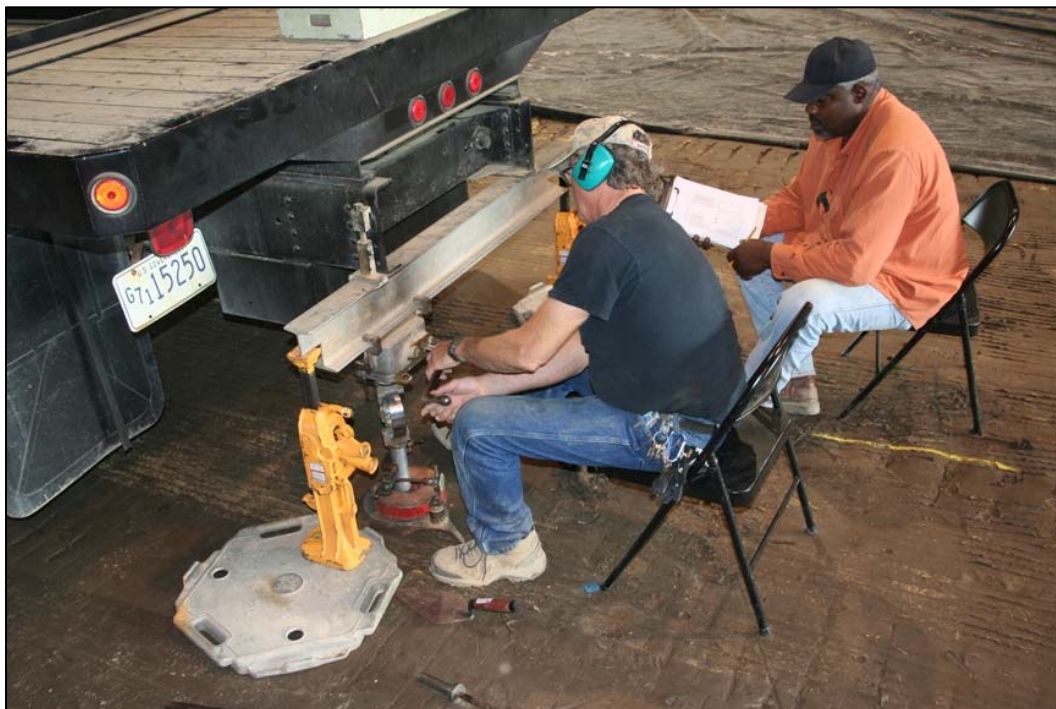
Figure 10. Performing an in situ CBR test on the subgrade.

CBR tests were mainly designed for subgrade and subbase material but can be completed on base course materials (American Society for Testing and Materials 2004). Also, it is important to note that CBR tests indicate the strength of the soil at the time of testing. If, for example, the moisture content changes after a CBR test, the strength of the soil (CBR) will also most likely change. The procedure used for completing the in situ CBR tests can be found in ASTM D 4429-04. Figure 10 shows a CBR test being conducted on the subgrade material.

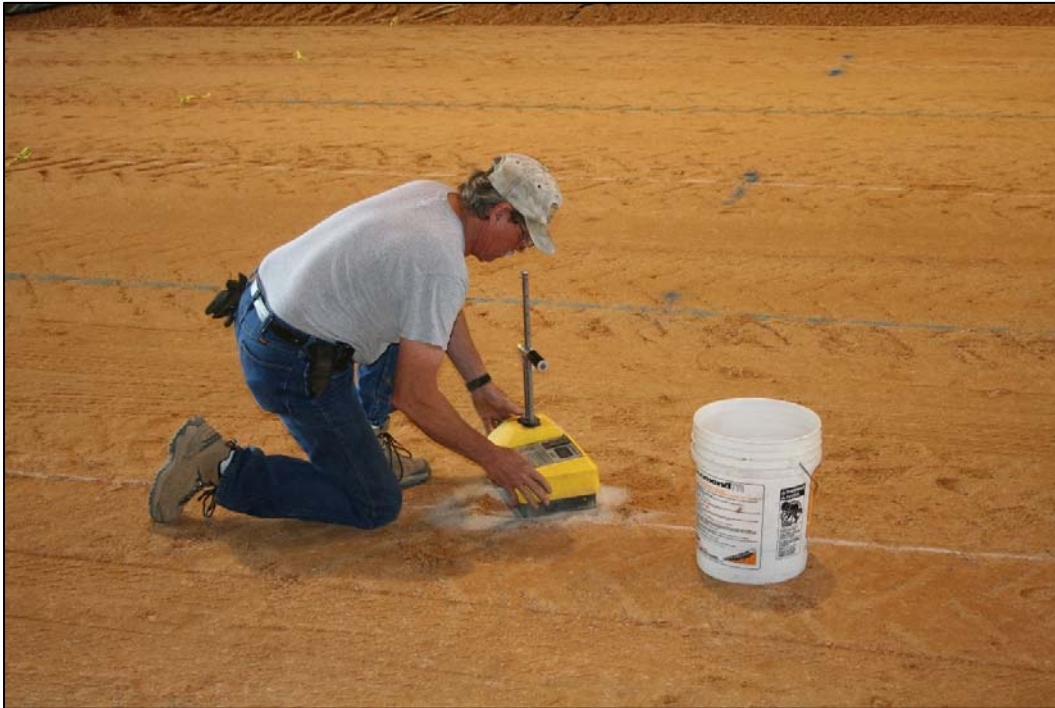
Figure 12. Nuclear gauge testing on the subbase material.

The Troxler nuclear moisture-density gauge (Figure 12), calibrated using a certified Primary Calibration Standard Block, was used throughout the pavement structure to rapidly measure each layer's respective density and moisture content. Using the density gauge replaces the traditional density test methods described in ASTM D 6938, ASTM D 2950, and ASTM C 1040. The nuclear gauge reports the dry density, wet density, and percent moisture. To use the nuclear gauge, the surface to be tested is smoothed, and sand is spread out over the area to fill any voids. A steel rod (about 1-in. diam) is driven into the surface and removed so that the rod attached to the nuclear gauge, which is used to measure the properties, can easily be inserted. The nuclear gauge device sits on top of the surface until the test is complete. The measurements are presented on the screen of the instrument. The detailed procedure can be found in ASTM D 6938-08a.

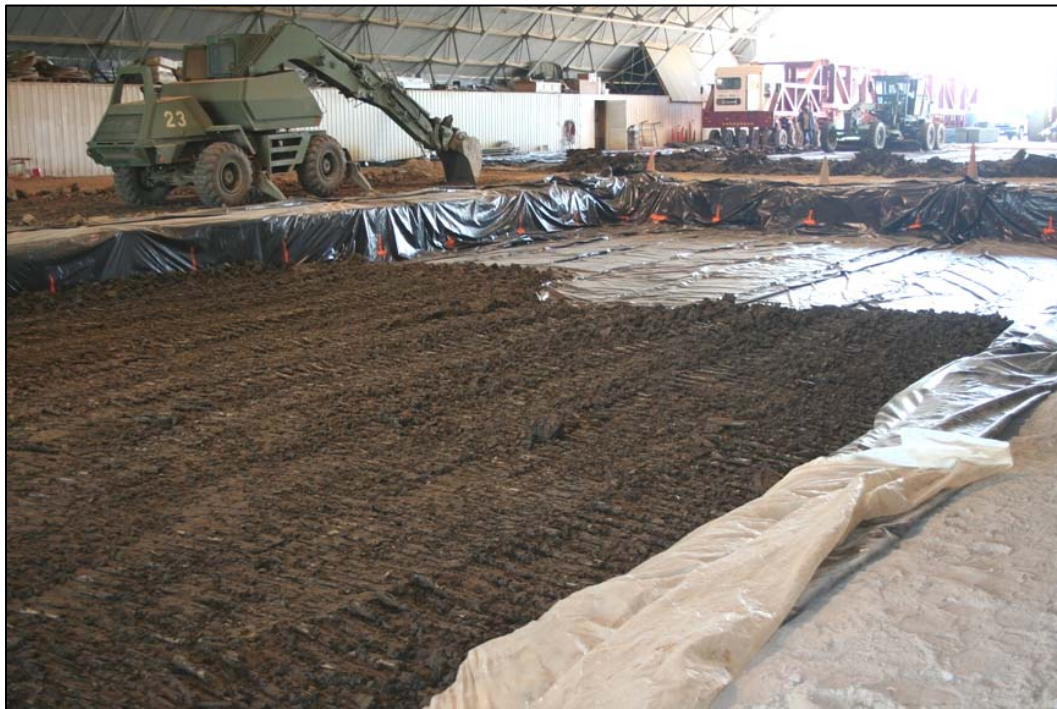
Figure 13. One lift of CH material before compaction.

Each lift was compacted using a rubber tire roller to approximately 6 in. for a total thickness of about 18 in. The subgrade was then finished using a steel wheel roller in order to achieve a smooth surface. Each compacted lift was subjected to nuclear density, nuclear moisture, oven moisture, DCP, and CBR testing following the methods described in Chapter 3 to ensure the desired values were reached. The CH material easily achieved the target CBR of approximately 10% (Table 8). Figure 13 shows a lift of the CH material in the test pit before compaction.

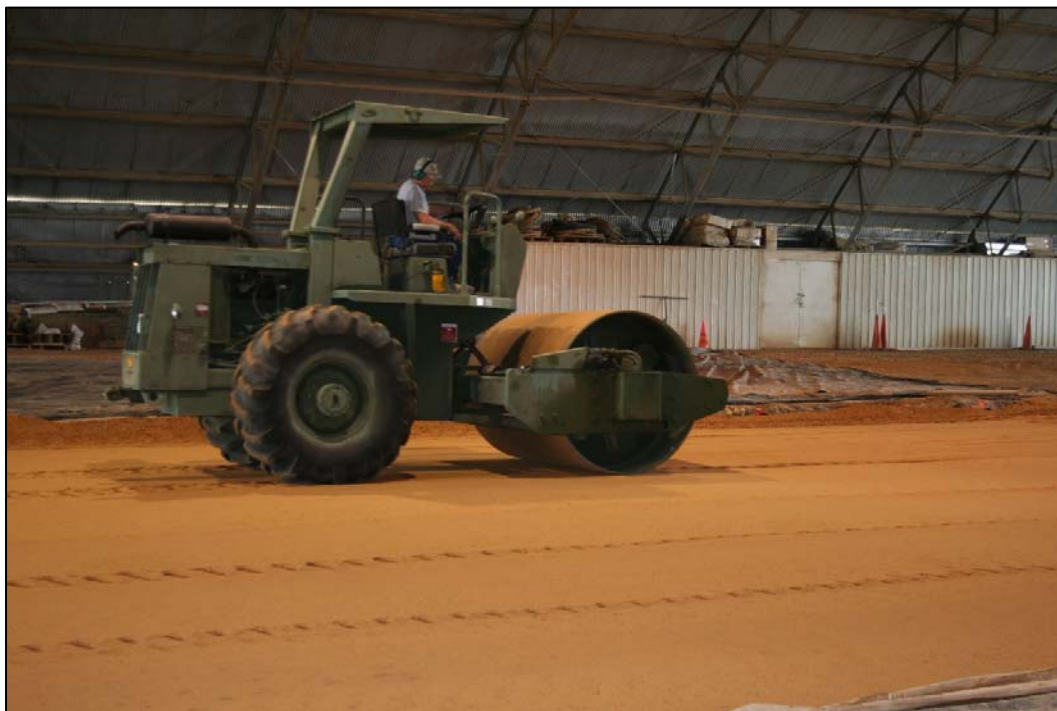
Figure 14. Compacting the subbase material.

The final compacted subbase (Figure 14) was subjected to nuclear density, nuclear moisture, oven moisture, and DCP testing to ensure the desired measurements were reached. CBR tests were not conducted on the subbase because the material was too loose; accurate measurements could not be achieved. The strength of the subbase material, determined using the DCP, was a CBR of approximately 42 to 55% (Table 6). Target CBR was 30%; however, there were no minimum or maximum strength requirements for the subbase. The material was constructed of a suitable strength

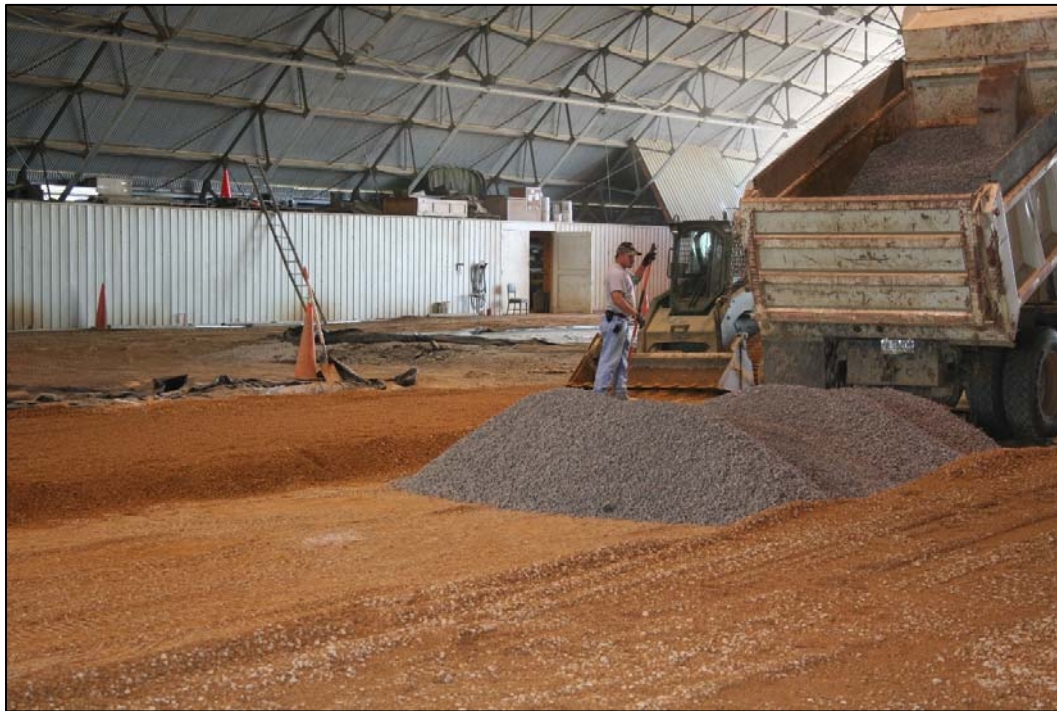
Figure 15. Placing crushed limestone between the crushed gravel base courses.

The base course material for Items 3 and 4 consisted of crushed limestone. For these items, the crushed limestone material was placed in one 8-in. uncompacted lift and compacted to about 6.5 in. Density and moisture measurements were comparable with the laboratory results, and the material reached a CBR of approximately 95.6 to 100% (Table 8). The elevation and levelness of all base material was verified by centerline and cross section profile readings. Figure 15 shows the limestone being placed between the two crushed gravel base course lanes.

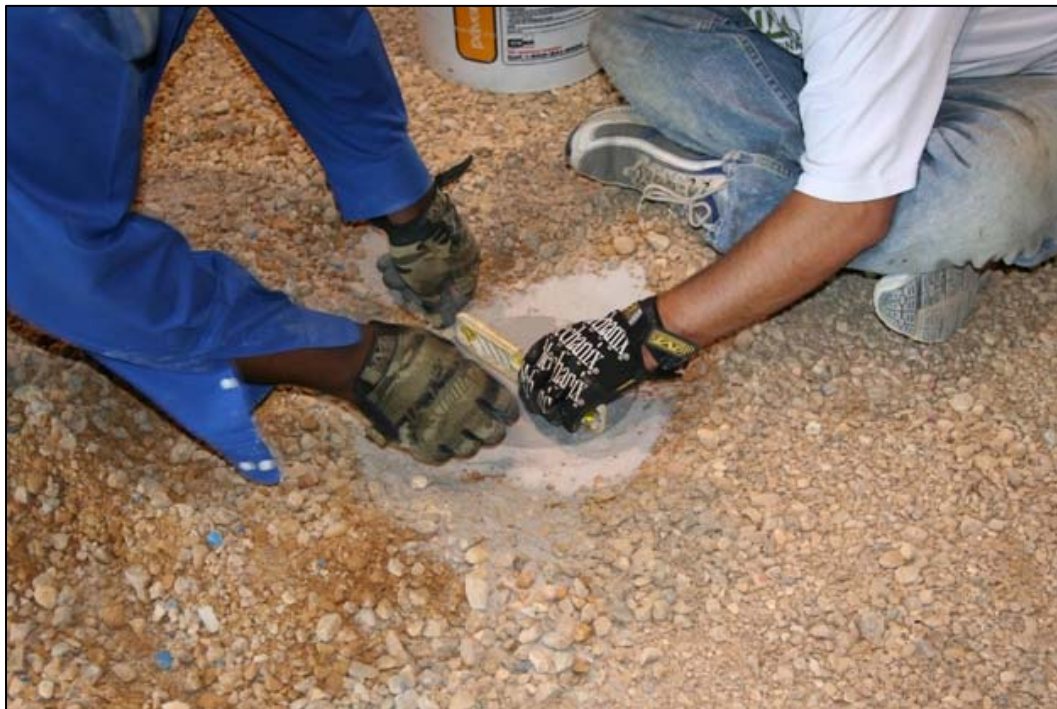
Figure 18. EPC installation in a crushed gravel base course layer.

Each item was instrumented with four 9-in.-diam EPC, one SDD, and four asphalt concrete strain gauges (two gauges perpendicular to each other) to measure the in situ pavement response to the aircraft loading. EPCs were placed 2 in. into the base, 4 in. into the subbase, and 4 in. into the subgrade to measure the vertical stress distribution through the pavement system caused by the wheel load and tire pressure. Two EPCs were placed in the subgrade to ensure that an accurate measurement was recorded. SDDs were installed 4 in. into the subgrade to measure the deflection and permanent deformation received from the loads. Strain gauges were placed at the bottom of the asphalt concrete (top of the base) to measure the tensile strain received at the bottom of the pavement. The strain gauges were placed parallel and perpendicular to traffic. Each gauge was installed directly on the centerline within the pavement structure. Figure 3 (Chapter 2) presents a schematic of the instrumentation layout for the items, and Figure 18 shows an EPC being installed in a base course layer.

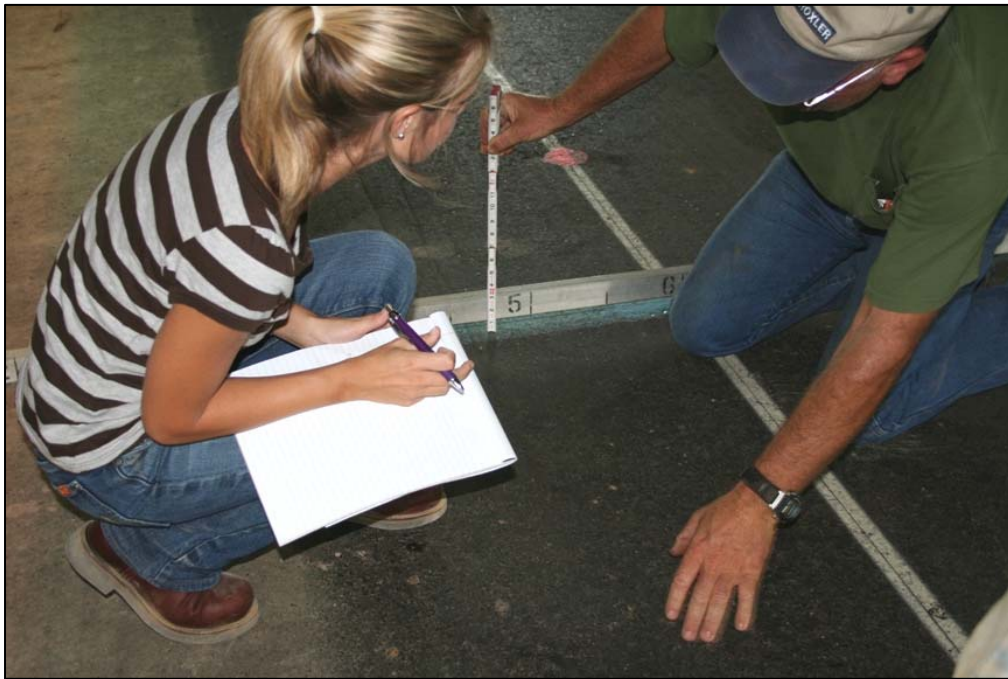
Figure 24. Taking rut depth measurements.

At selected traffic intervals, the traffic was stopped, and the asphalt concrete pavements were inspected for distresses such as cracking and rutting. Rut depth measurements were recorded on the centerline, west of the centerline, and east of the centerline at each quarter point (Figure 24). If the average permanent deformation of the surface increased 1/8 in. or more, a full data set of measurements (FWD, centerline profile, cross section profiles, and instrumentation response) was collected. Otherwise, trafficking continued until the desired number of passes was achieved. This procedure was repeated until the permanent deformation reached approximately 1.5 to 2 in. The following paragraphs further explain the data collection procedures.

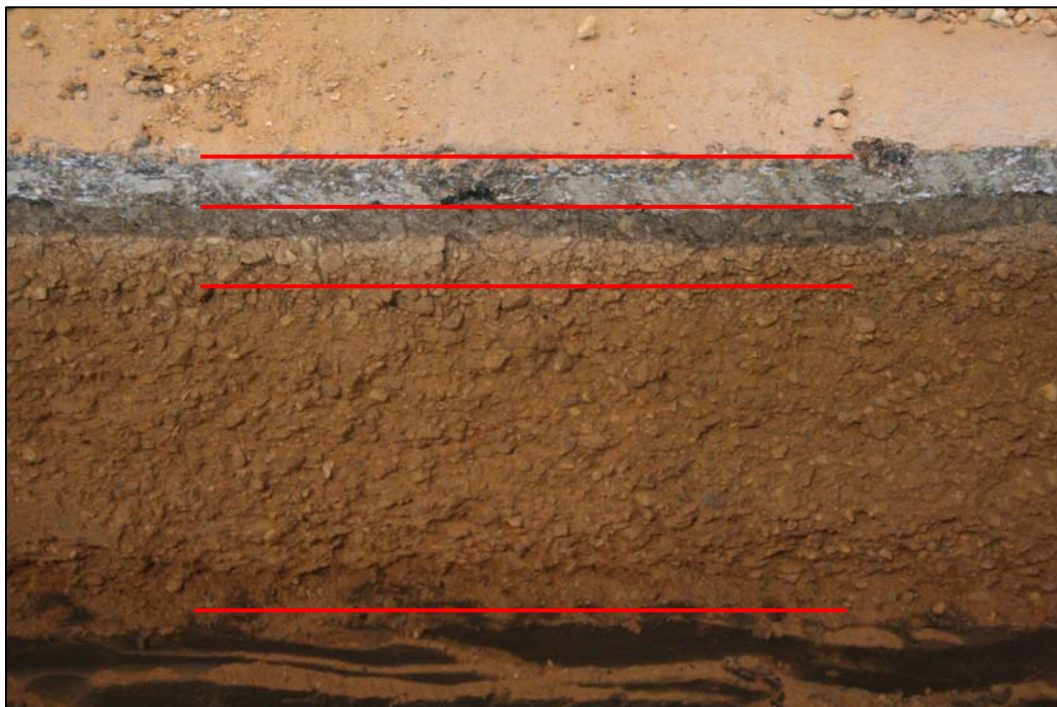
Figure 38. Item 1 trenched profile view.

Failure location in the pavement structure of any of the items was not clear based on visual inspection alone. The items were not trafficked to catastrophic failure, so it was difficult to visually pinpoint which layer or layers may have had movement. Visual inspection did show that there was no evidence of subgrade pumping in Item 1 because the subbase was not contaminated with clay. Figure 38 shows a profile view of Item 1 after trenching. The picture is of the center of the rut. From the picture, it is difficult to distinguish between the base and subbase material, so red lines were drawn to show each layer.

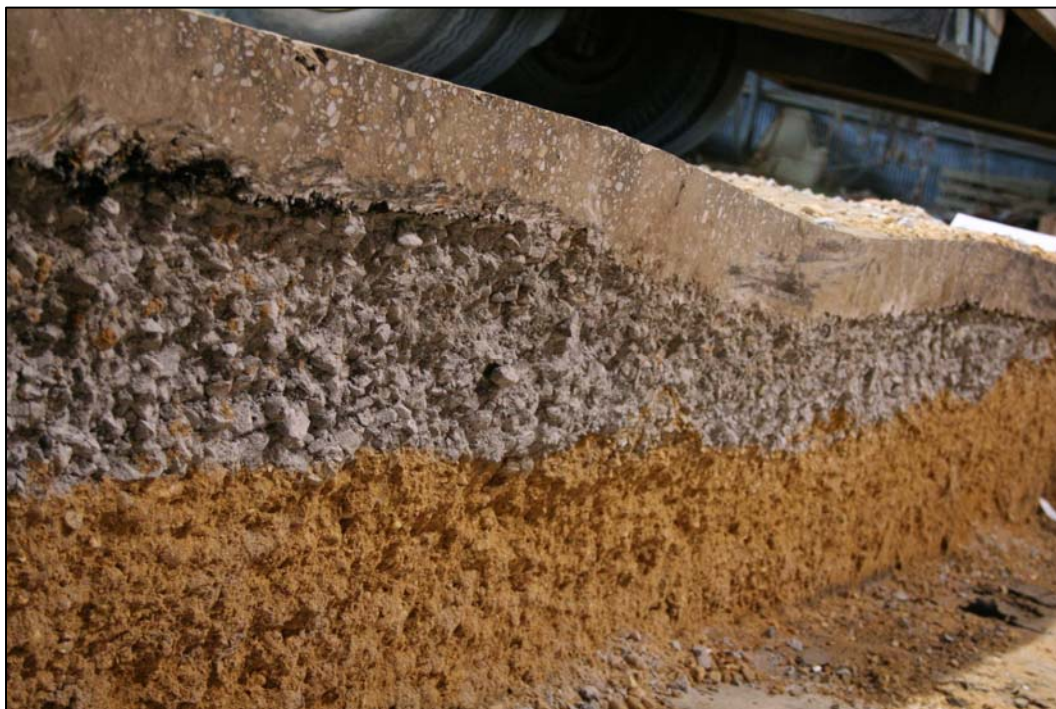
Figure 72. Item 4 trenched profile view.
